## KG6SII's AREDN firmware loading issues – 4/10/22

Errors I get when trying to flash 3.22.1.0 onto a Ubiquiti Rocket M5 and Ubiquiti NanoStation M5:

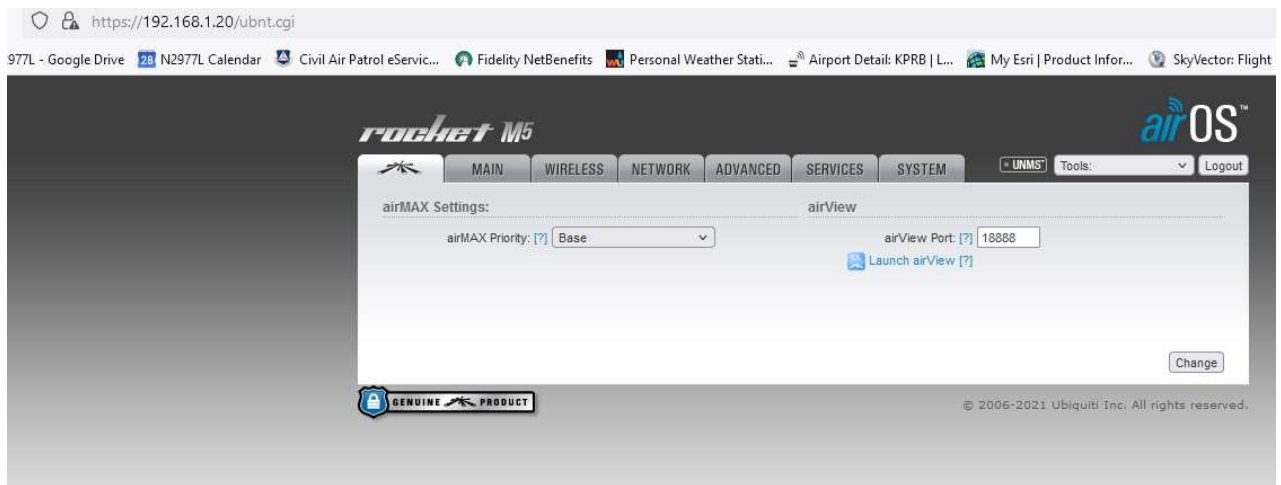
The screenshot shows the web interface for a Ubiquiti Rocket M5. The browser address bar displays `https://192.168.1.20/ubnt.cgi`. The interface includes a navigation menu with tabs for MAIN, WIRELESS, NETWORK, ADVANCED, SERVICES, and SYSTEM. The current page is titled "airMAX Settings" and "airView". Under "airMAX Settings", there is a dropdown menu for "airMAX Priority" set to "Base". Under "airView", there is a text input field for "airView Port" set to "18888" and a "Launch airView" button. A "Change" button is located at the bottom right of the settings area. The interface also features a "GENUINE PRODUCT" logo and a copyright notice: "© 2006-2021 Ubiquiti Inc. All rights reserved."

- Used a cable tester on all my cables, found 1 cable with a bad connection on pin 8, stopped using that cable
- Got a 10/100 switch
- Got a PoE injector from Amazon (non-Ubiquiti brand, this is last in line after the 10/100 switch, before the radio)
- Tried loading all available firmware files (-m, -xw, etc., unplugging everything in between each attempt, re-doing the radio reset sequence)
- Pings now report fine: 4/4, 0% loss, 0ms
- The radios have an old Ubiquiti AirOS loaded on them (v6.3.6 XW). See existing firmware settings below for the Rocket:
